1. Project Name: Rota SBH
2. Date of Inspection: July 23, 2007
3. Inspection Personnel:

4. Discussion:

Prestorm Revetted Mole - 535 LF:

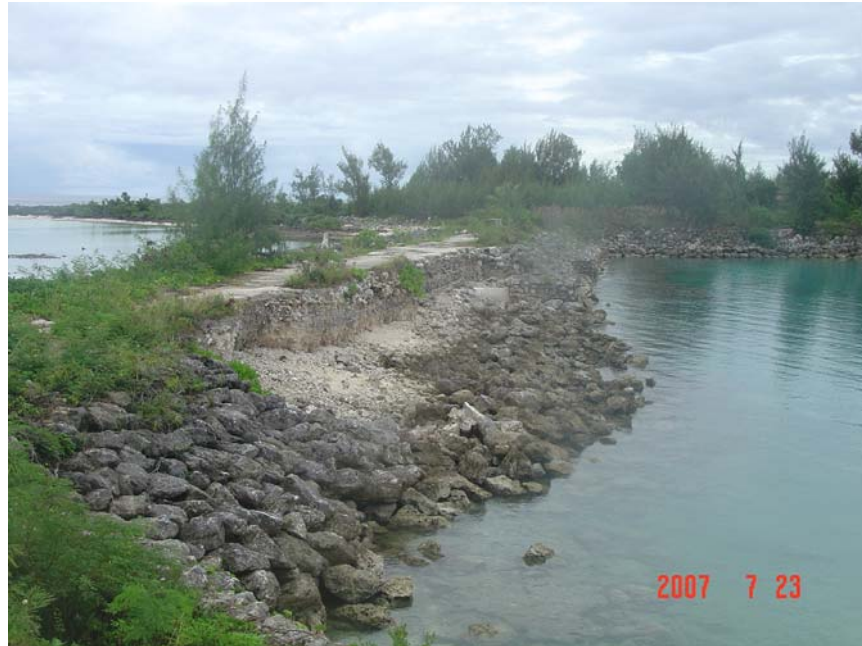
a. Sta. 0+00, HS, Overview of damages.

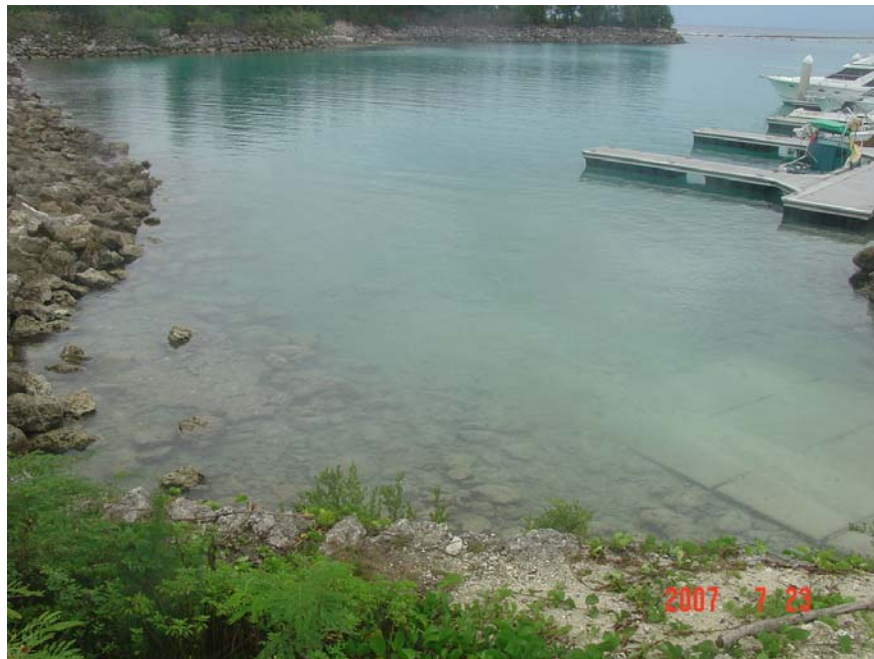
b. Boat Ramp Area adjacent to Sta. 0+50, armor stones have washed into the launch area and impacts boaters.

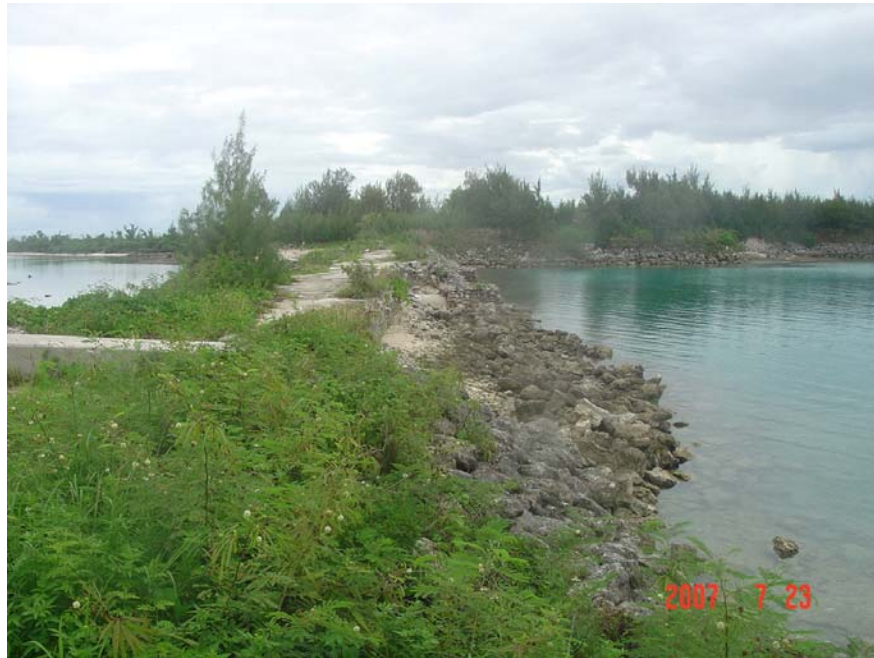
c. Sta. 0+10, HS, Overview

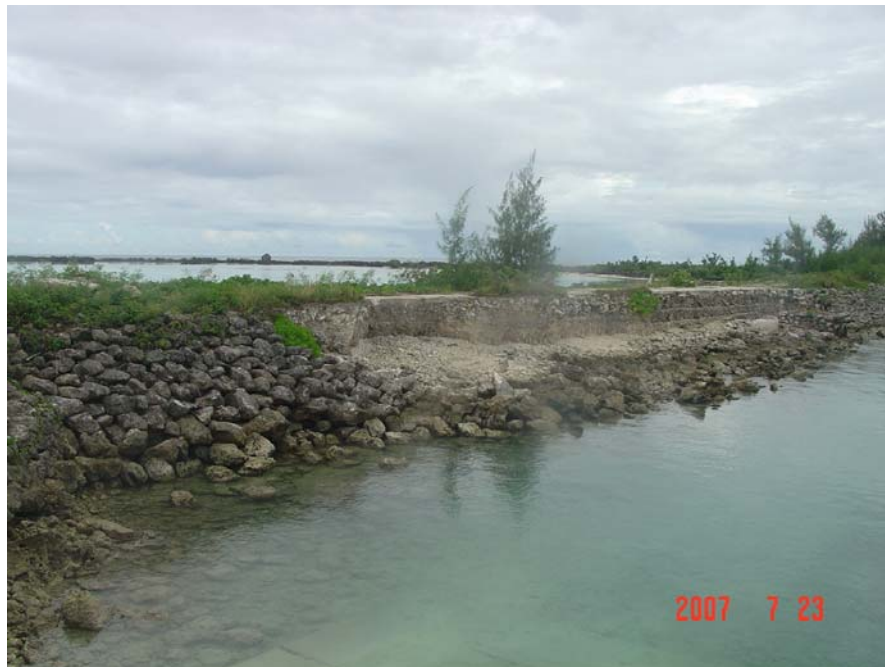
d. Sta. 0+50, HS, Beginning of major damages to the sideslope.

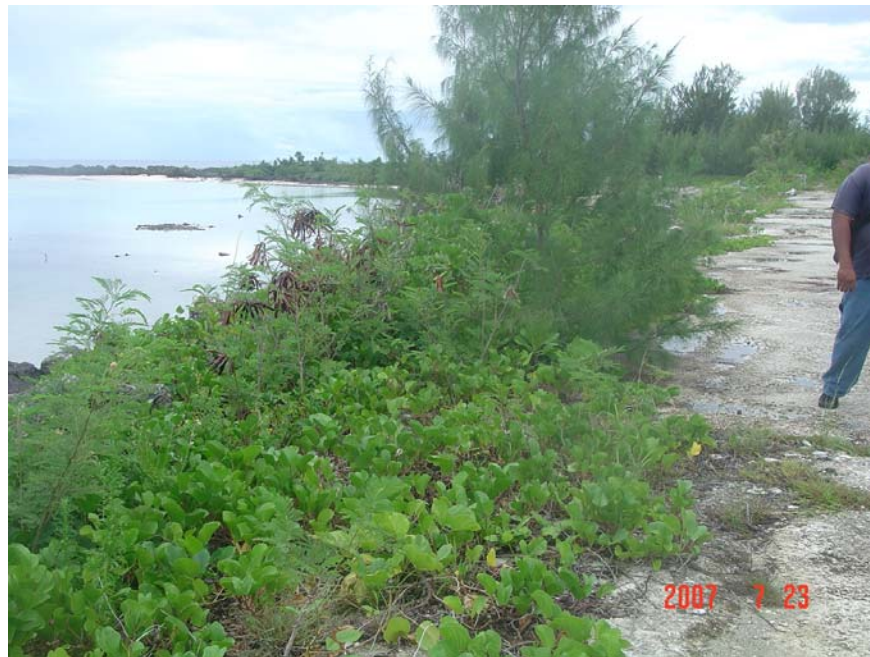
e. Sta. 1+00, OS, Numerous flipped armor stone covered by vegetation.

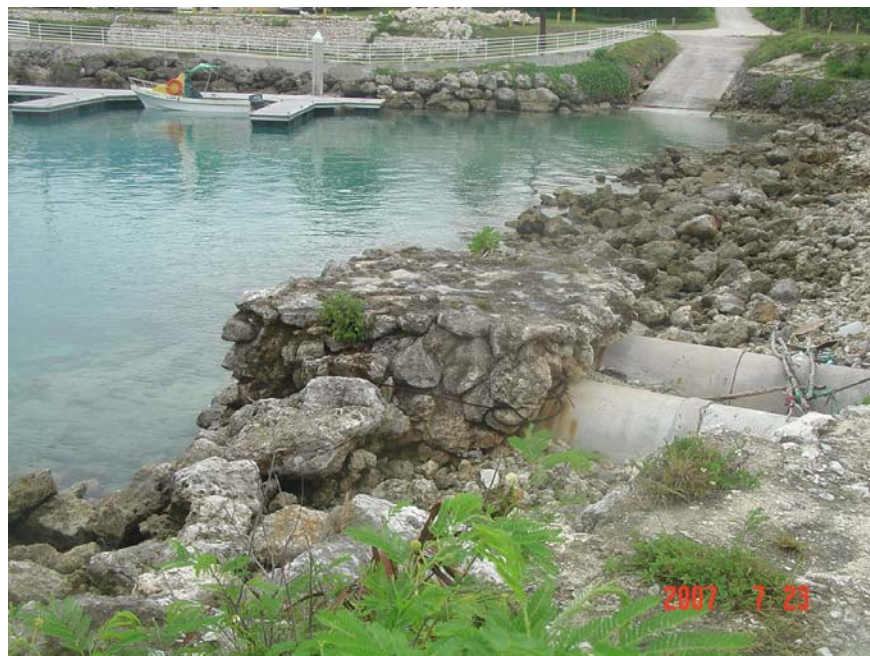
f. Sta. 1+86, HS, 36" culverts are exposed and additional erosion this inspection.

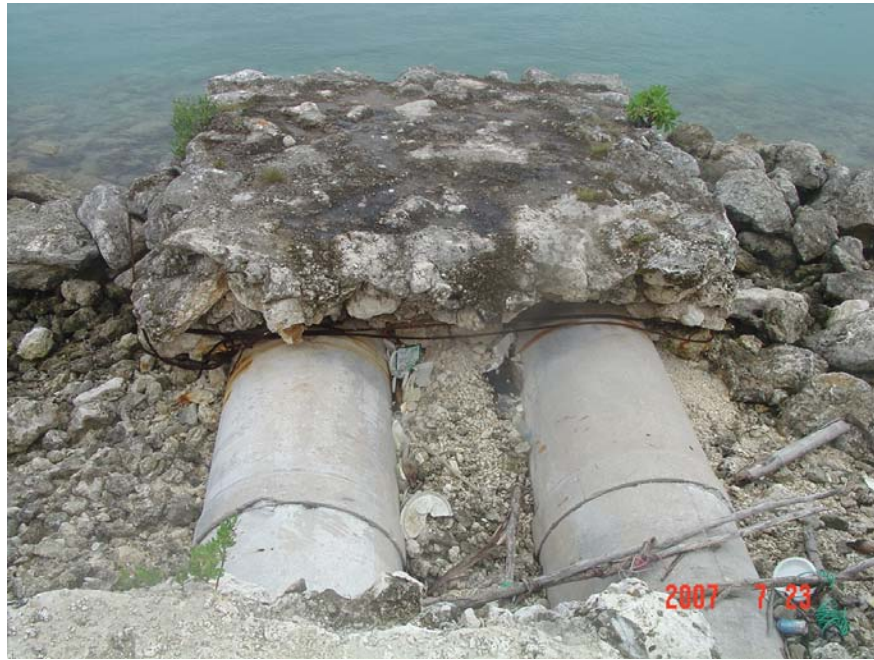
g. Sta. 1+86, same as above.

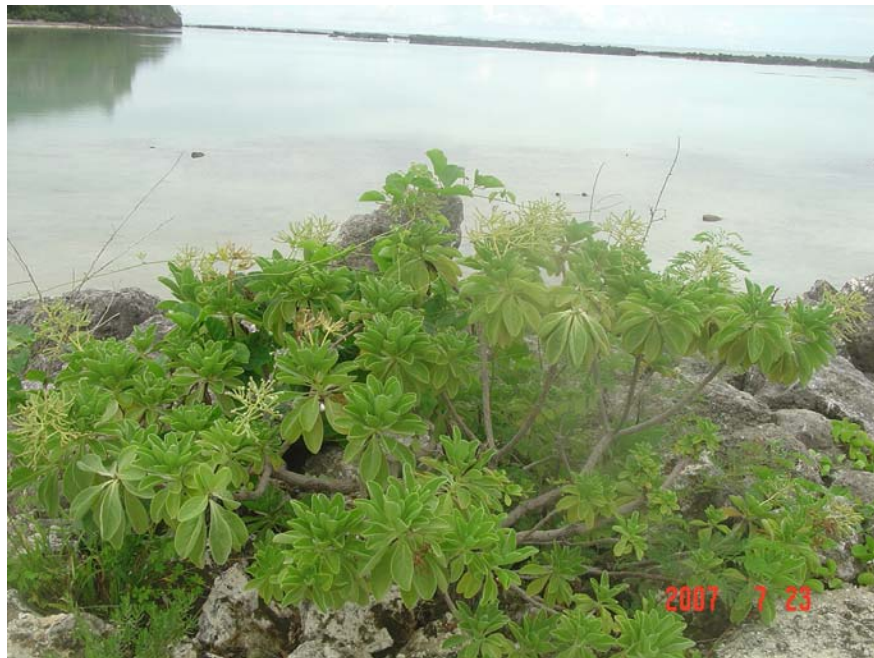
h. Sta. 1+90, OS, flipped armor stone.

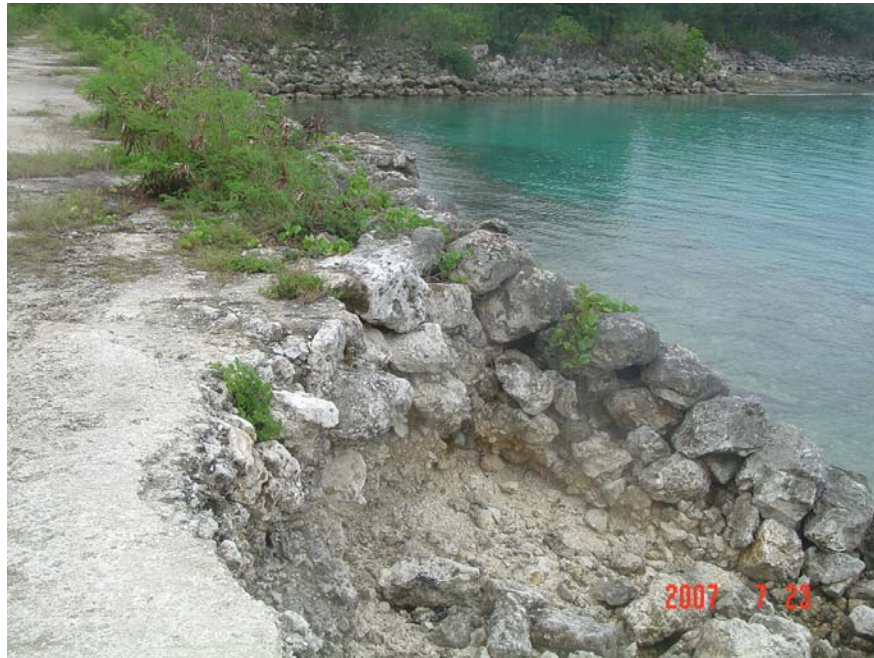
i. Sta. 2+22, HS, End of major failure.

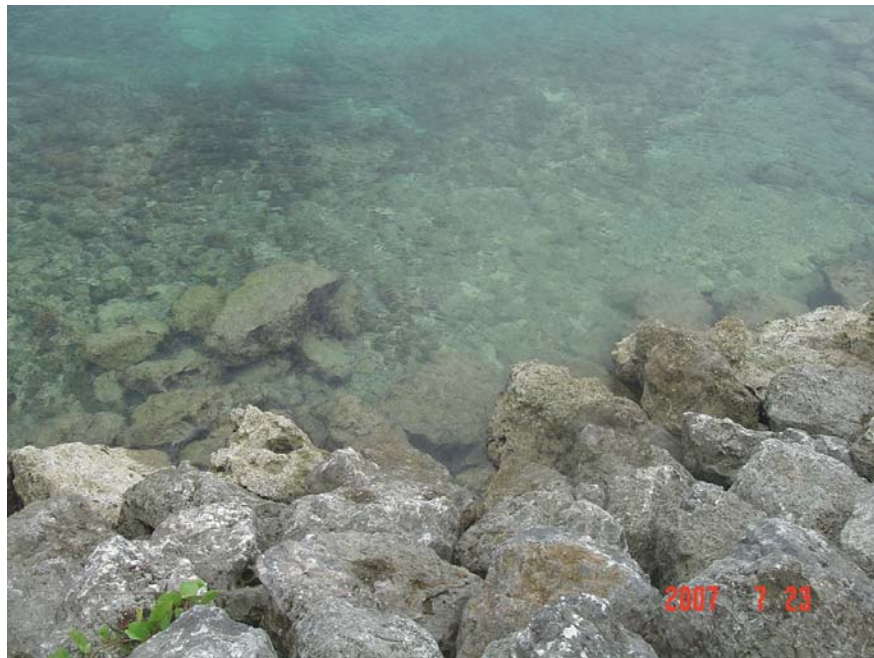
j. Sta. 2+33, HS, missing toe armor stone.

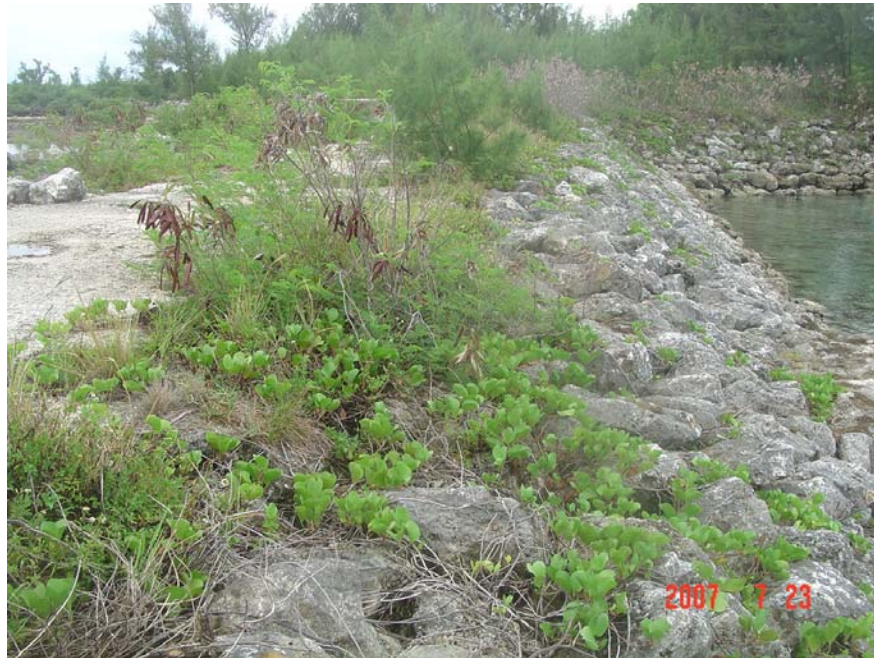
k. Sta. 2+52 to Sta. 2+59, HS, missing armor stones at the hinge of the sideslope.

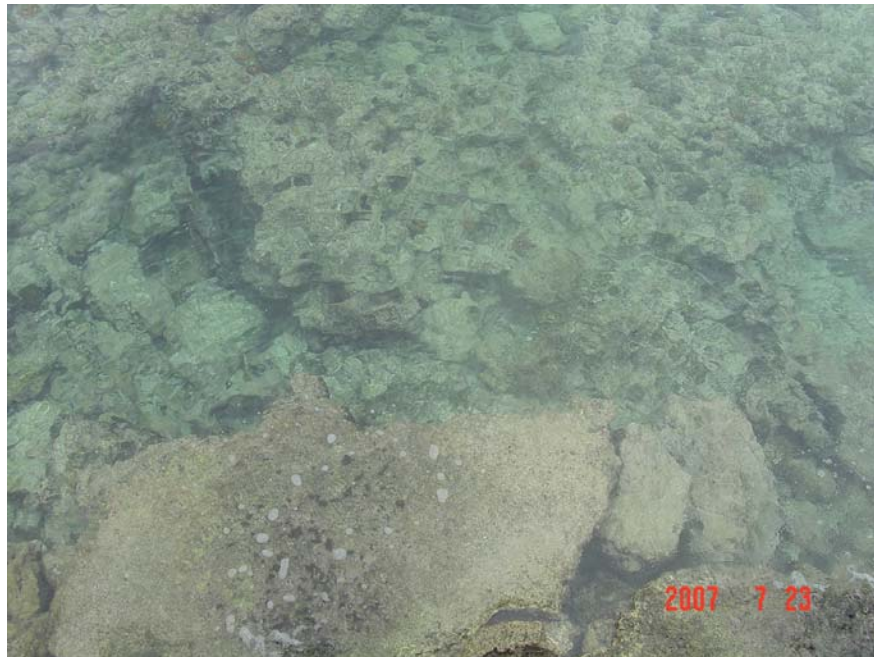
l. Sta. 2+76 HS, Splash apron damages and culverts undermined, drainage culvert cracked.

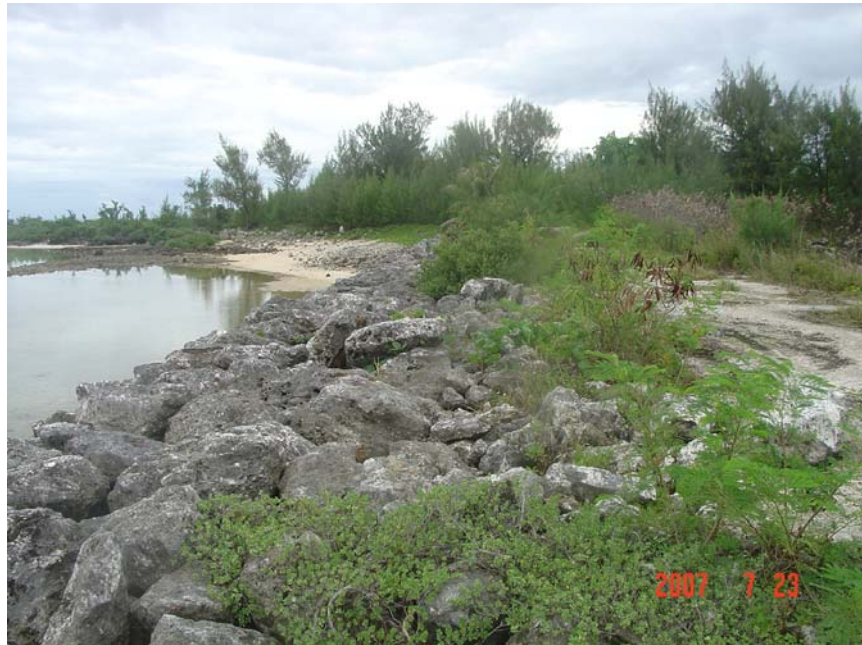
m. Sta. 2+77, OS, 10' x 10' depressed area w/flipped armor stones.

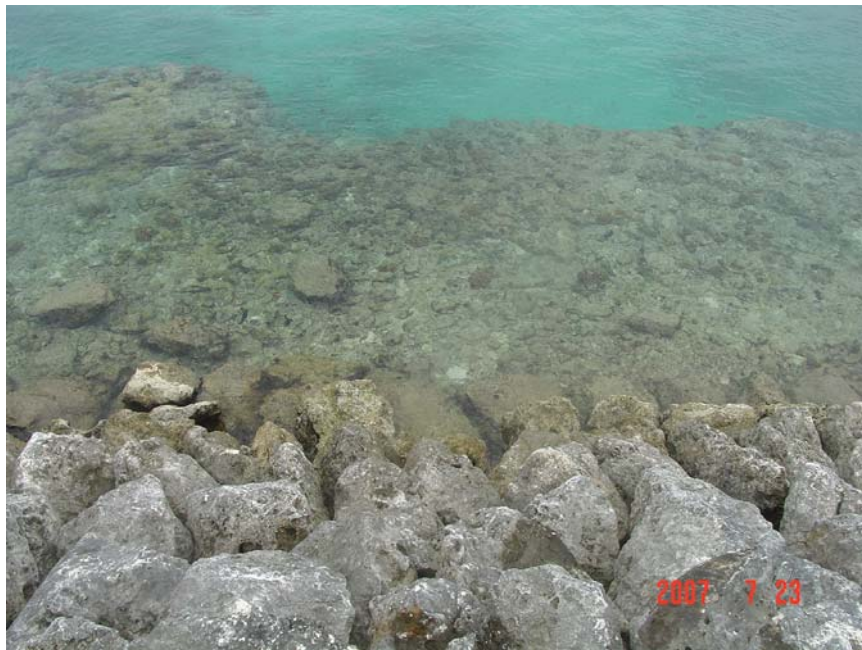
n. Sta. 3+12, HS, missing toe armor stone.

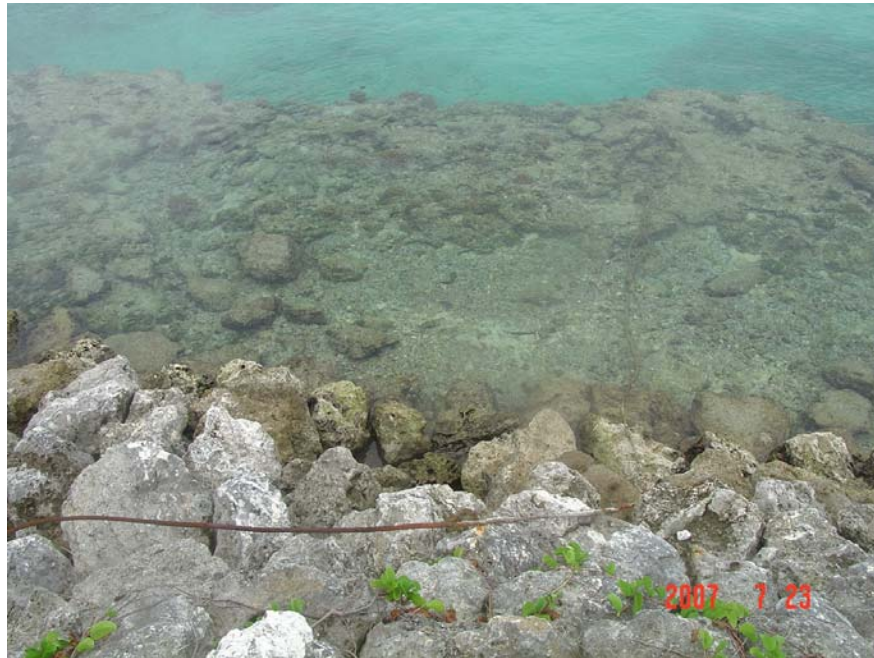
o. Sta. 3+50, HS, 2 ea. missing toe armor stones, remove wire rope.

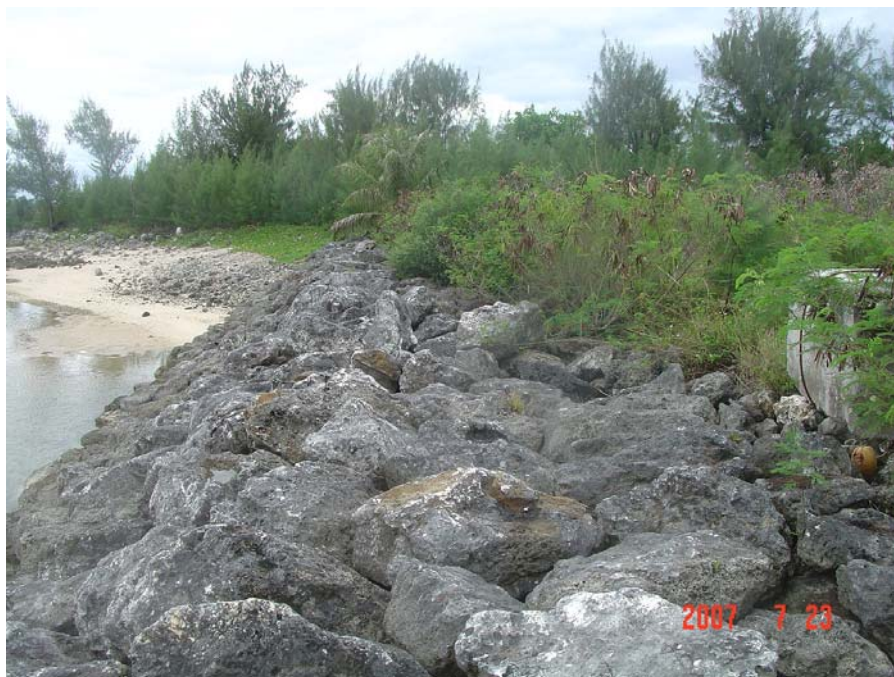
p. Sta. 3+50, OS, unable to inspect crest due to vegetation however numerous flipped armor stones need to be reset.

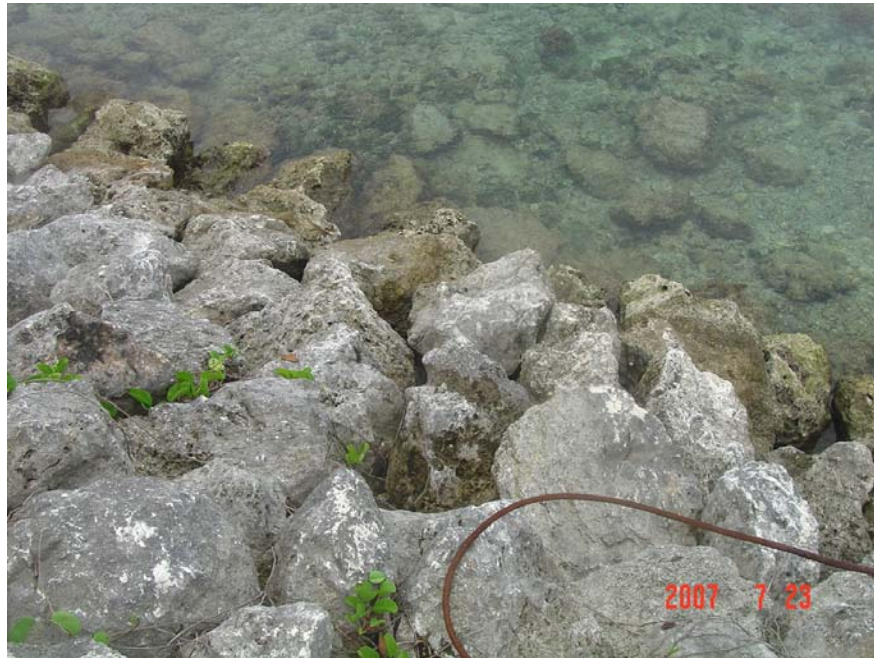
q. Sta. 3+55, missing armor stone approximately 4 ft up the sideslope from the toe.

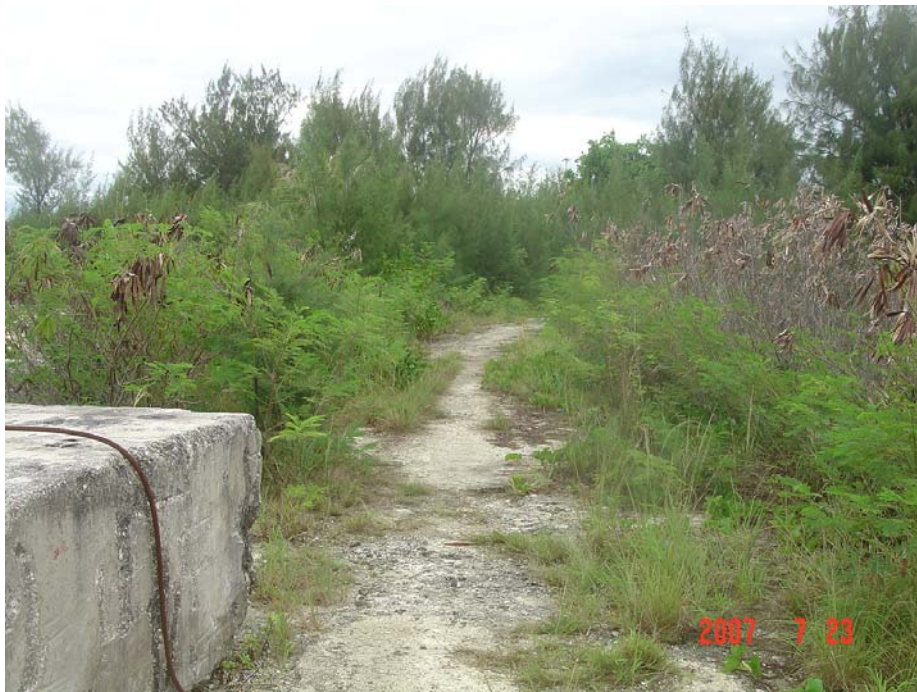
r. Sta. 3+59 to Sta. 3+84, HS, approximately 20 ea. missing armor stone to the hinge if the sideslope.

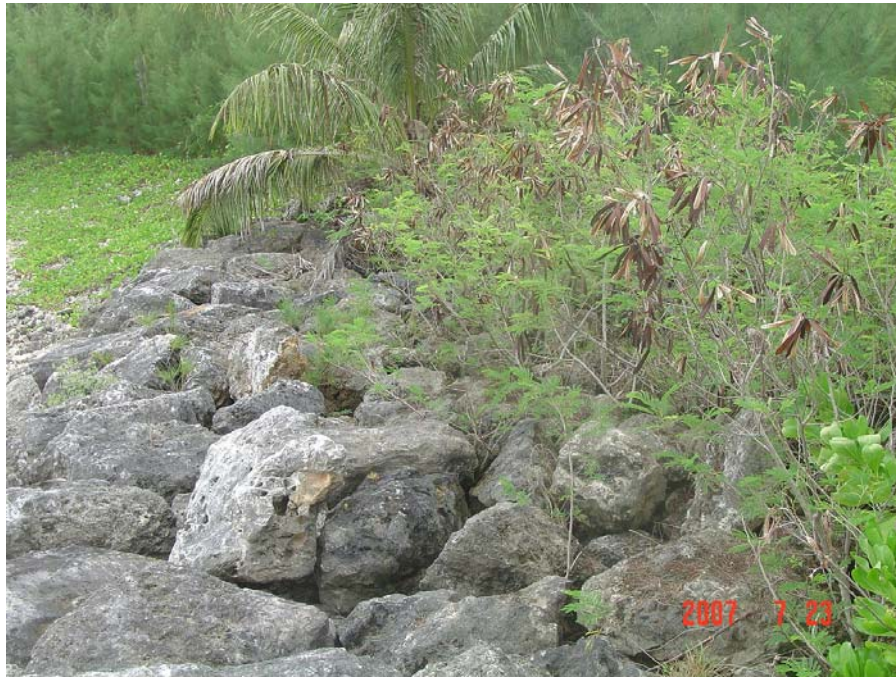
s. Sta. 5+00, OS, flipped armor stones, overgrown w/vegetation.

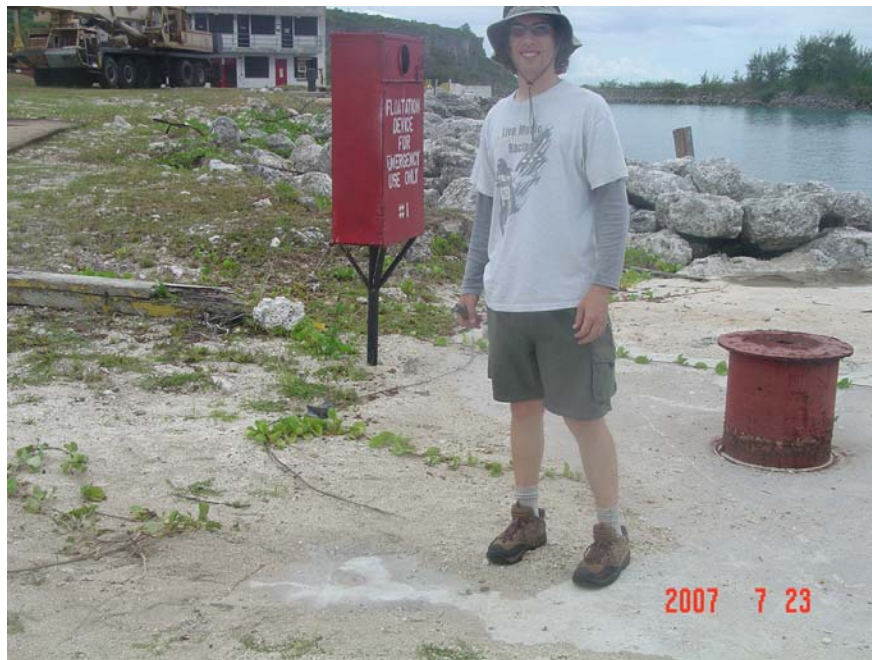
Brass Survey Disk installed at Dock # 1. Survey information provided to National Geodetic Service and will be added to NGS's database. NGS TAM1 was noted disturbed, reported to NGS and should not be used.
